MSANK Wet Weather Management Program

November 2010 Newsletter

Phase 1 Construction Complete

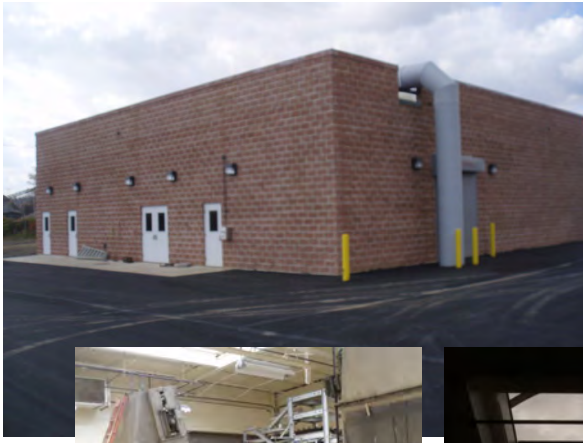
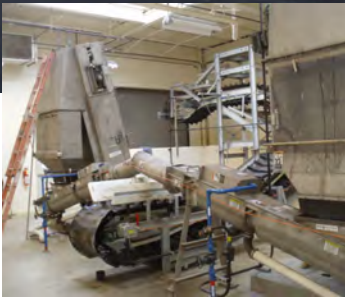
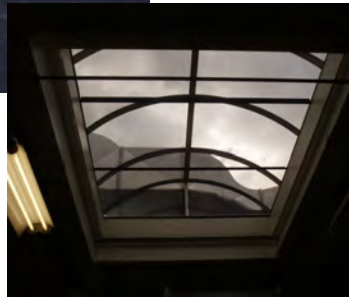
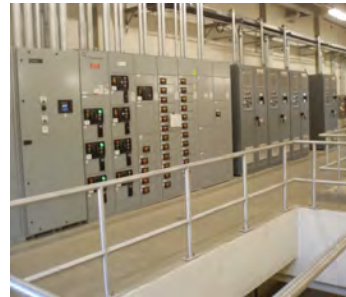
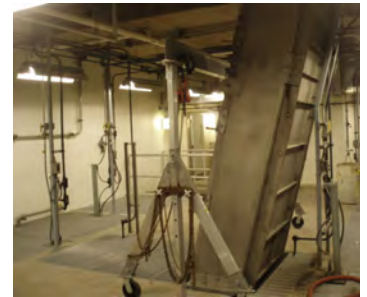
The new pump station, pictured left and below, houses raw sewage screening equipment (pictured below, far right), compaction and conveyor equipment (pictured below, far left), and pumping motor control center (below, middle right), in addition to wastewater containment wells where raw sewage enters the pumping station. Skylights in the roof (pictured below, middle left) serve to aid natural lighting of the space, however, their primary purpose is for access for potential future maintenance of the bar screens. Although the new pump station building appears like a one-story structure from street level, it is four stories deep underground.

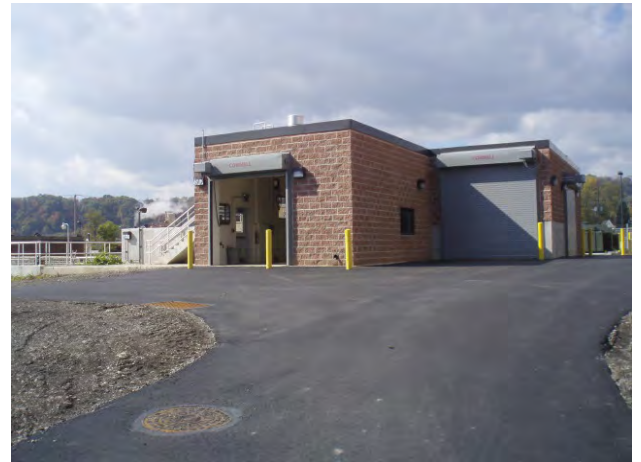
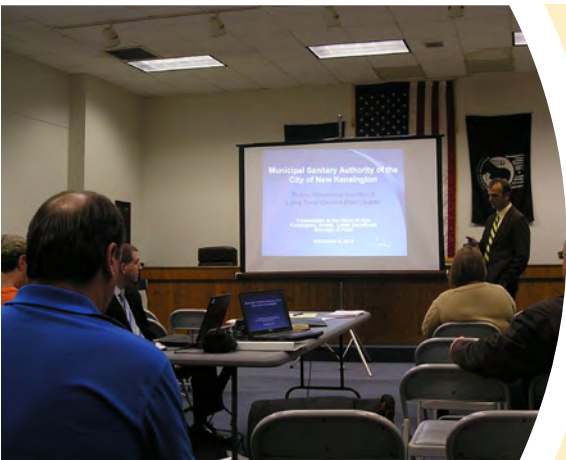
The new grit facility, pictured to the right, separates inorganic solids from the waste stream. The grit building (far right) is a one-story structure that contains a basement that houses grit pumps (near right) that transfer separated solid material onto a conveyor for further handling. Once the solids are separated from the wastewater, the partially treated flow (see waterfall-like image to right) undergoes several more treatment steps before it is acceptable for final discharge.
